the Welding Defects DECODED

Case Studies on Welding Defects

Issue 001

Jul-Sep 2017

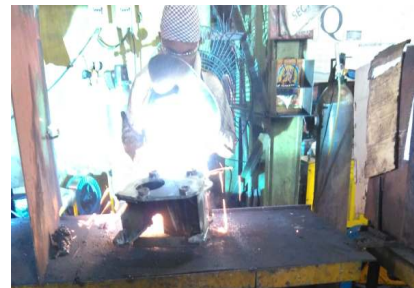
Upon observation, we could make out that there was problem with the arc. The arc got deflected every time it was struck. This led to a bad weld. The deflection of arc or arc blow led us to some other theory. We checked the workpiece connection, the joint design, the equipment settings etc. All seemed fine too. We understood that we need to look beyond this...

We got the material to test for its composition. The result showed that there was around 9% of Nickel in the stainless steel. A higher percentage of Nickel increased the magnetic susceptibility of the steel. This led to a deflection of Arc or Arc blow during welding.

welding should have taken care of magnetism. But in our case, that seemed not enough. Since we could not change the material at that time, we worked towards demagnetization and achieved a sound welding.

Demagnetisation is a costly and time consuming process that can best be avoided by using the correct material with Nickel content in stainless steel (SS304) not going preferably beyond 8%. This saves upon a lot of effort in rectifying the issues that otherwise arise due to magnetism. Only preheating may not yield results.

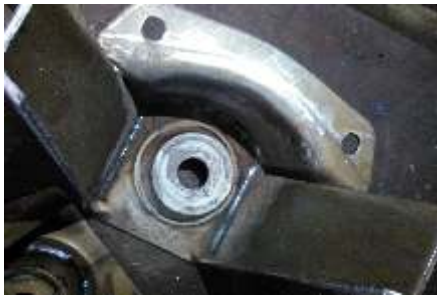
The 20mm thick sheet was MIG welded with a single V groove. However, the non uniform cooling issue and the residual stress thus formed led to angular distortion in the welded plate. The distortion though was very little, but none the less that gave me an out of proportion finished component.

the plates straight. Then I tried to work on the edge preparation that was easy – the V groove that I was already working on. However, there was a change this time. I tried double V groove. And yes, it worked!

I would consider that the double V groove worked for me both economically and qualitatively. The edge preparation did not require any special preparation. Double V was easy to get as the sheet was thick. What happens is, when we are welding on both sides, the stress developed by the filler metals and the heat generated during welding on one side is balanced by the stress

developed on the other side. This is probably easy as the edge preparation is viable.
